Manhole Inspection Summary

Manhole # S35MM_063MH

Insp Date: **3/5/07 12:04 PM**

Location Address: **332 20TH ST**

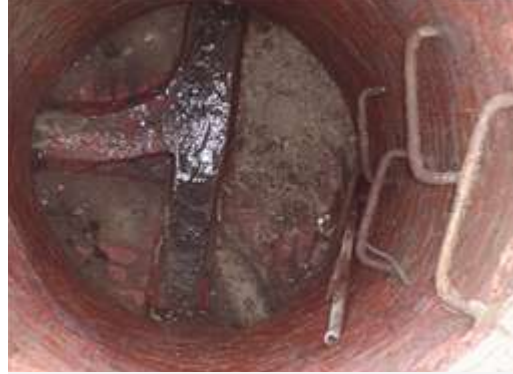
Top View

Corroded steps. Bench and Channel debris.

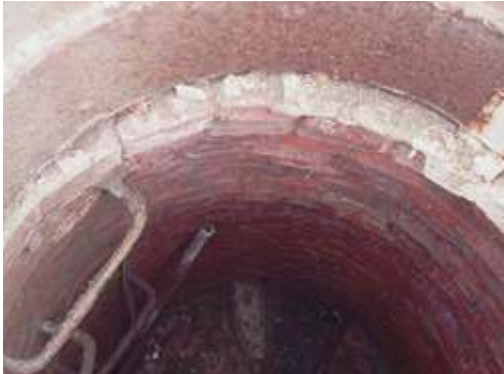
Defect

Frame offset. Adjustment deterioration, loose brick and infiltration. Corbel infiltration.

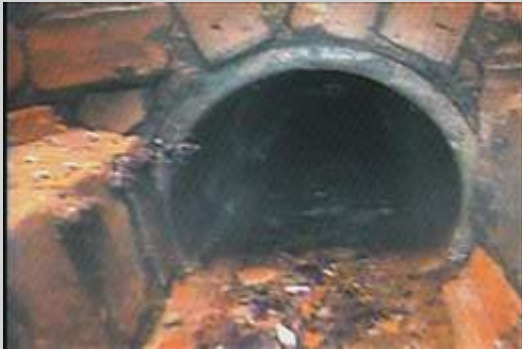
8 in. Circular Gravity Sewer Pipe Out @ 12 O'Clock

Invert Depth: **8.81** (ft.) Flow Characteristics: **Slow**

Deposits: ☐ None ☒ **Mud** ☐ Sludge ☒ **Debris** ☐ Grease

Silt Depth: **0.5** (in.) Deposits Extent: **Light**

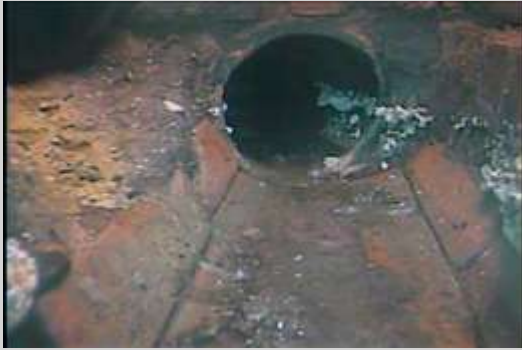
Pipe In @ 6 O'Clock

Invert Depth: **8.72** (ft.) Flow Characteristics: **Slow**

Deposits: ☐ None ☒ **Mud** ☐ Sludge ☐ Debris ☒ **Grease**

Silt Depth: **0** (in.) Deposits Extent: **Light**

Infiltration: **Evidence**
